14 BRAMLEY PLACE LENZIE GLASGOW G66 5LU

Energy Performance Certificate

14 BRAMLEY PLACE LENZIE GLASGOW G66 5LU Dwelling type: Semi-detached house

survey report on:

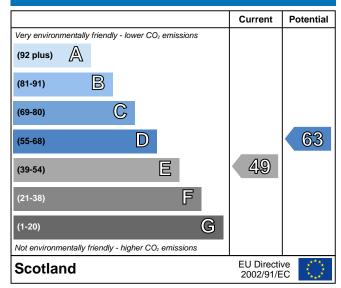
Environmental Impact (CO₂) Rating

The environmental impact rating is a measure of a home's impact on the environment in terms of carbon dioxide (CO₂) emissions. The higher the rating the less impact it has on the environment.

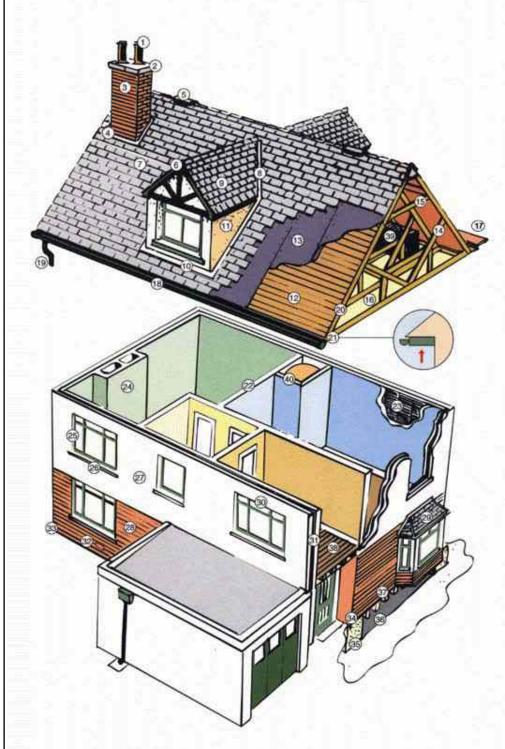
Sectional Diagram showing elements of a typical house

Reference may be made in this report to some or all of the above component parts of the property. This diagram may assist you in locating and understanding these items.

- 1 Chimney pots
- 2 Coping stone
- 3) Chimney head
- 4 Flashing
- (5) Ridge ventilation
- 6) Ridge board
- 7) Slates / tiles
- (8) Valley guttering
- 9) Dormer projection
- 10 Dormer flashing
- 11) Dormer cheeks
- (12) Sarking
- (13) Roof felt
- (14) Trusses
- 15) Collar
- (16) Insulation
- 17) Parapet gutter
- 18) Eaves guttering
- 19) Rainwater downpipe
- 0) Verge boards /skews
- 21) Soffit boards
- 22) Partition wall
- 23) Lath / plaster
- 24) Chimney breast
- \simeq .
- 25) Window pointing
- 26) Window sills
- (27) Rendering
- 28) Brickwork / pointing
- 29) Bay window projection
- 30 Lintels
- (31) Cavity walls / wall ties
- 32) Subfloor ventilator
- 33) Damp proof course
- 34) Base course
- 35) Foundations
- 36) Solum
- 37) Floor joists
- 38) Floorboards
- Water tank
- 40) Hot water tank
